# LEVEL II CORROSION OF 5456-H117 ALUMINUM IN HIGH VELOCITY SEAWATER

By G. A. GEHRING, JR.

Prepared for OFFICE of NAVAL RESEARCH

June 1978

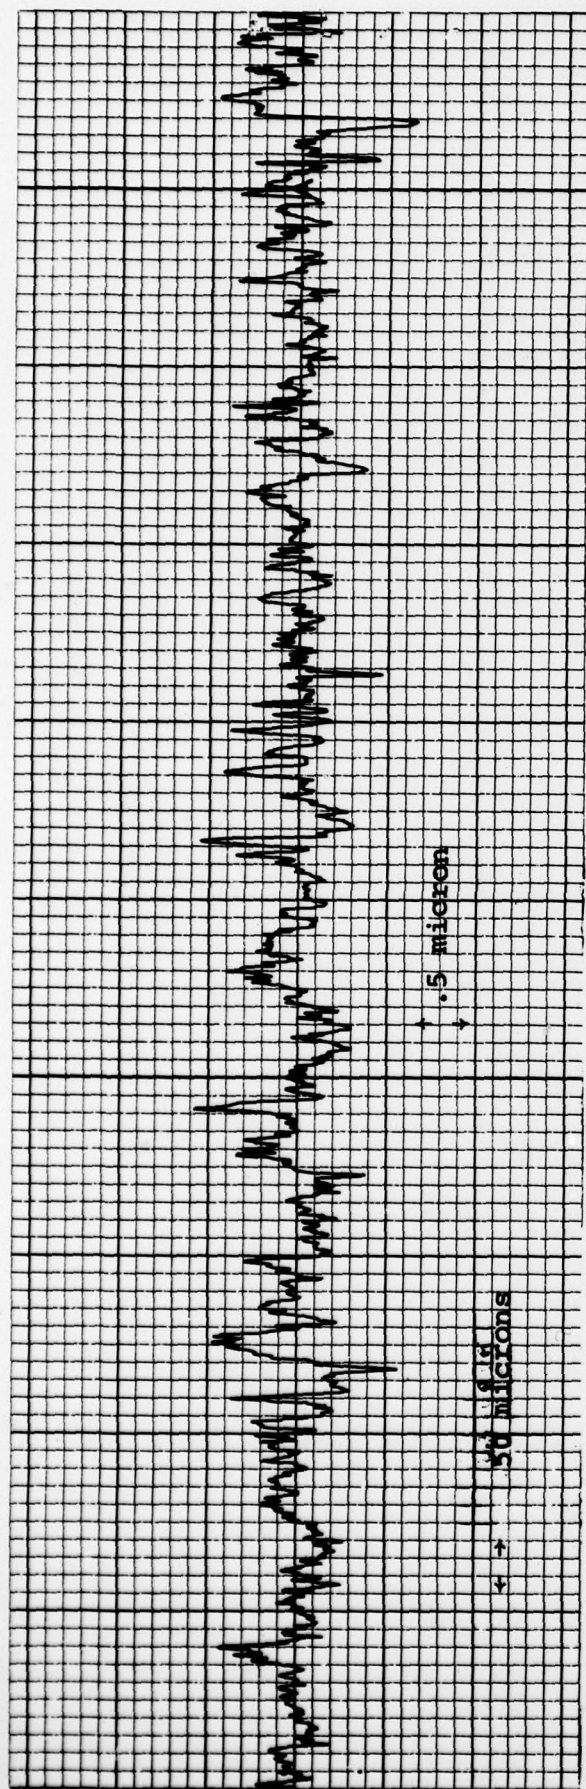
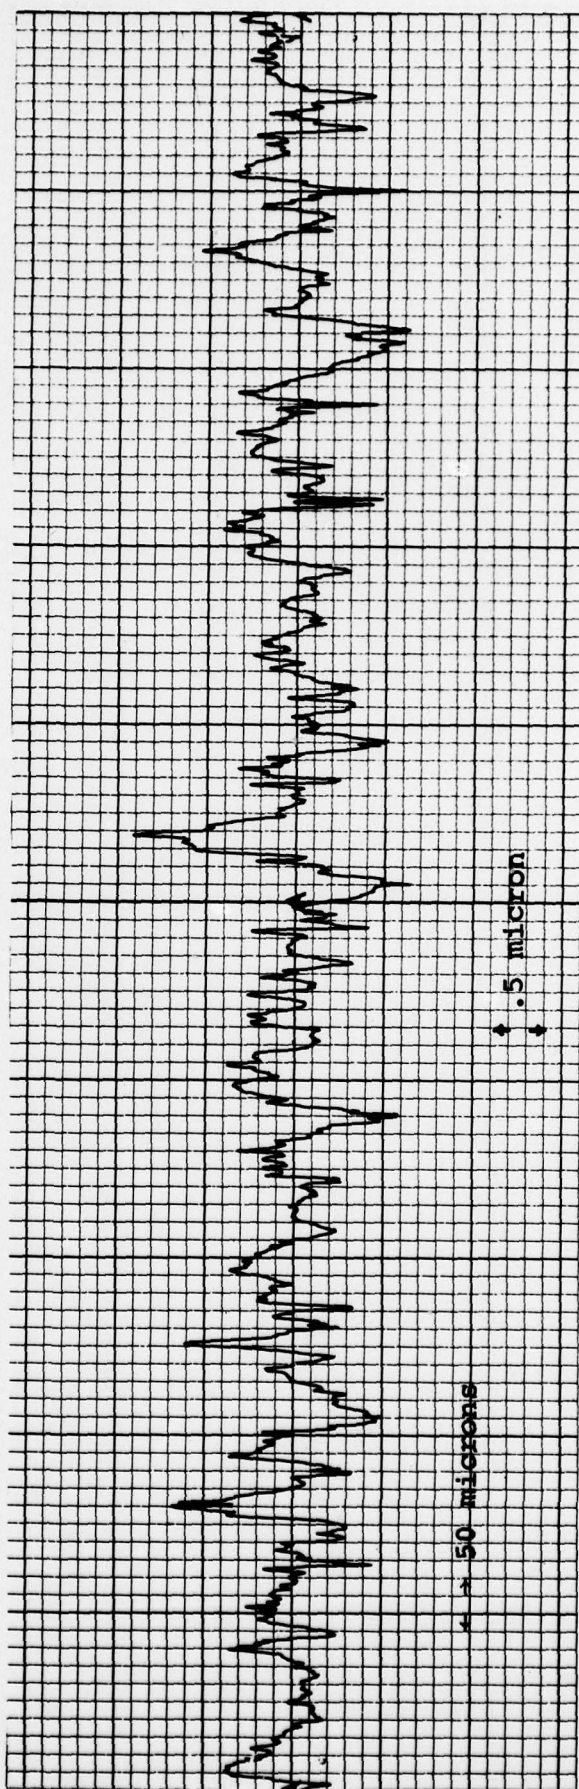
Figure 33 - Surface Profile Trace with Stylus  
Traversing Perpendicular to Rolling Direction

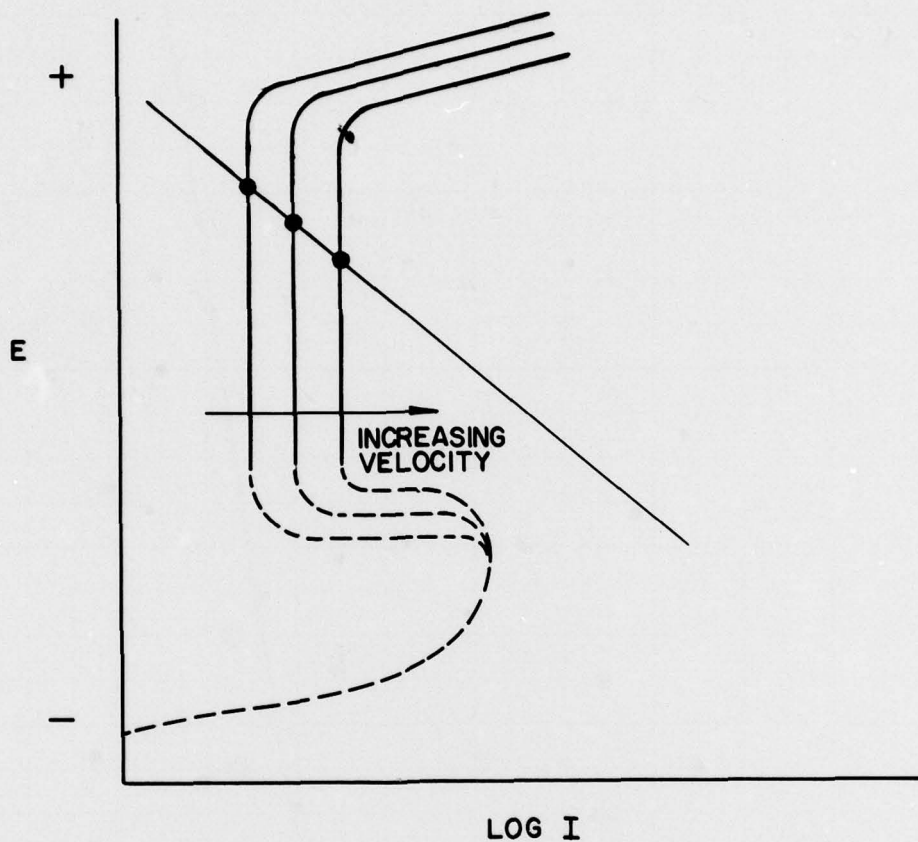
**FIGURE 35 - POLARIZATION DIAGRAM SHOWING THE EFFECT OF INCREASING VELOCITY ON THE DIFFUSION-LIMITED ANODIC POLARIZATION CURVE AND THE RESULTING ACTIVE SHIFT IN THE CORROSION POTENTIAL**

Figure 34 presents the average corrosion potential measured at each velocity over the 35 day test period. The corrosion potential exhibited a slight shift toward more active values as velocity increased. This is not surprising considering the results of the surface examination. A reduction in the thickness in the protective oxide layer would be expected to increase the diffusion-limited current density. If the cathodic polarization curve is unaffected by increases in velocity, the corrosion potential would be predicted to shift in the active direction as shown on a polarization diagram in Figure 35.

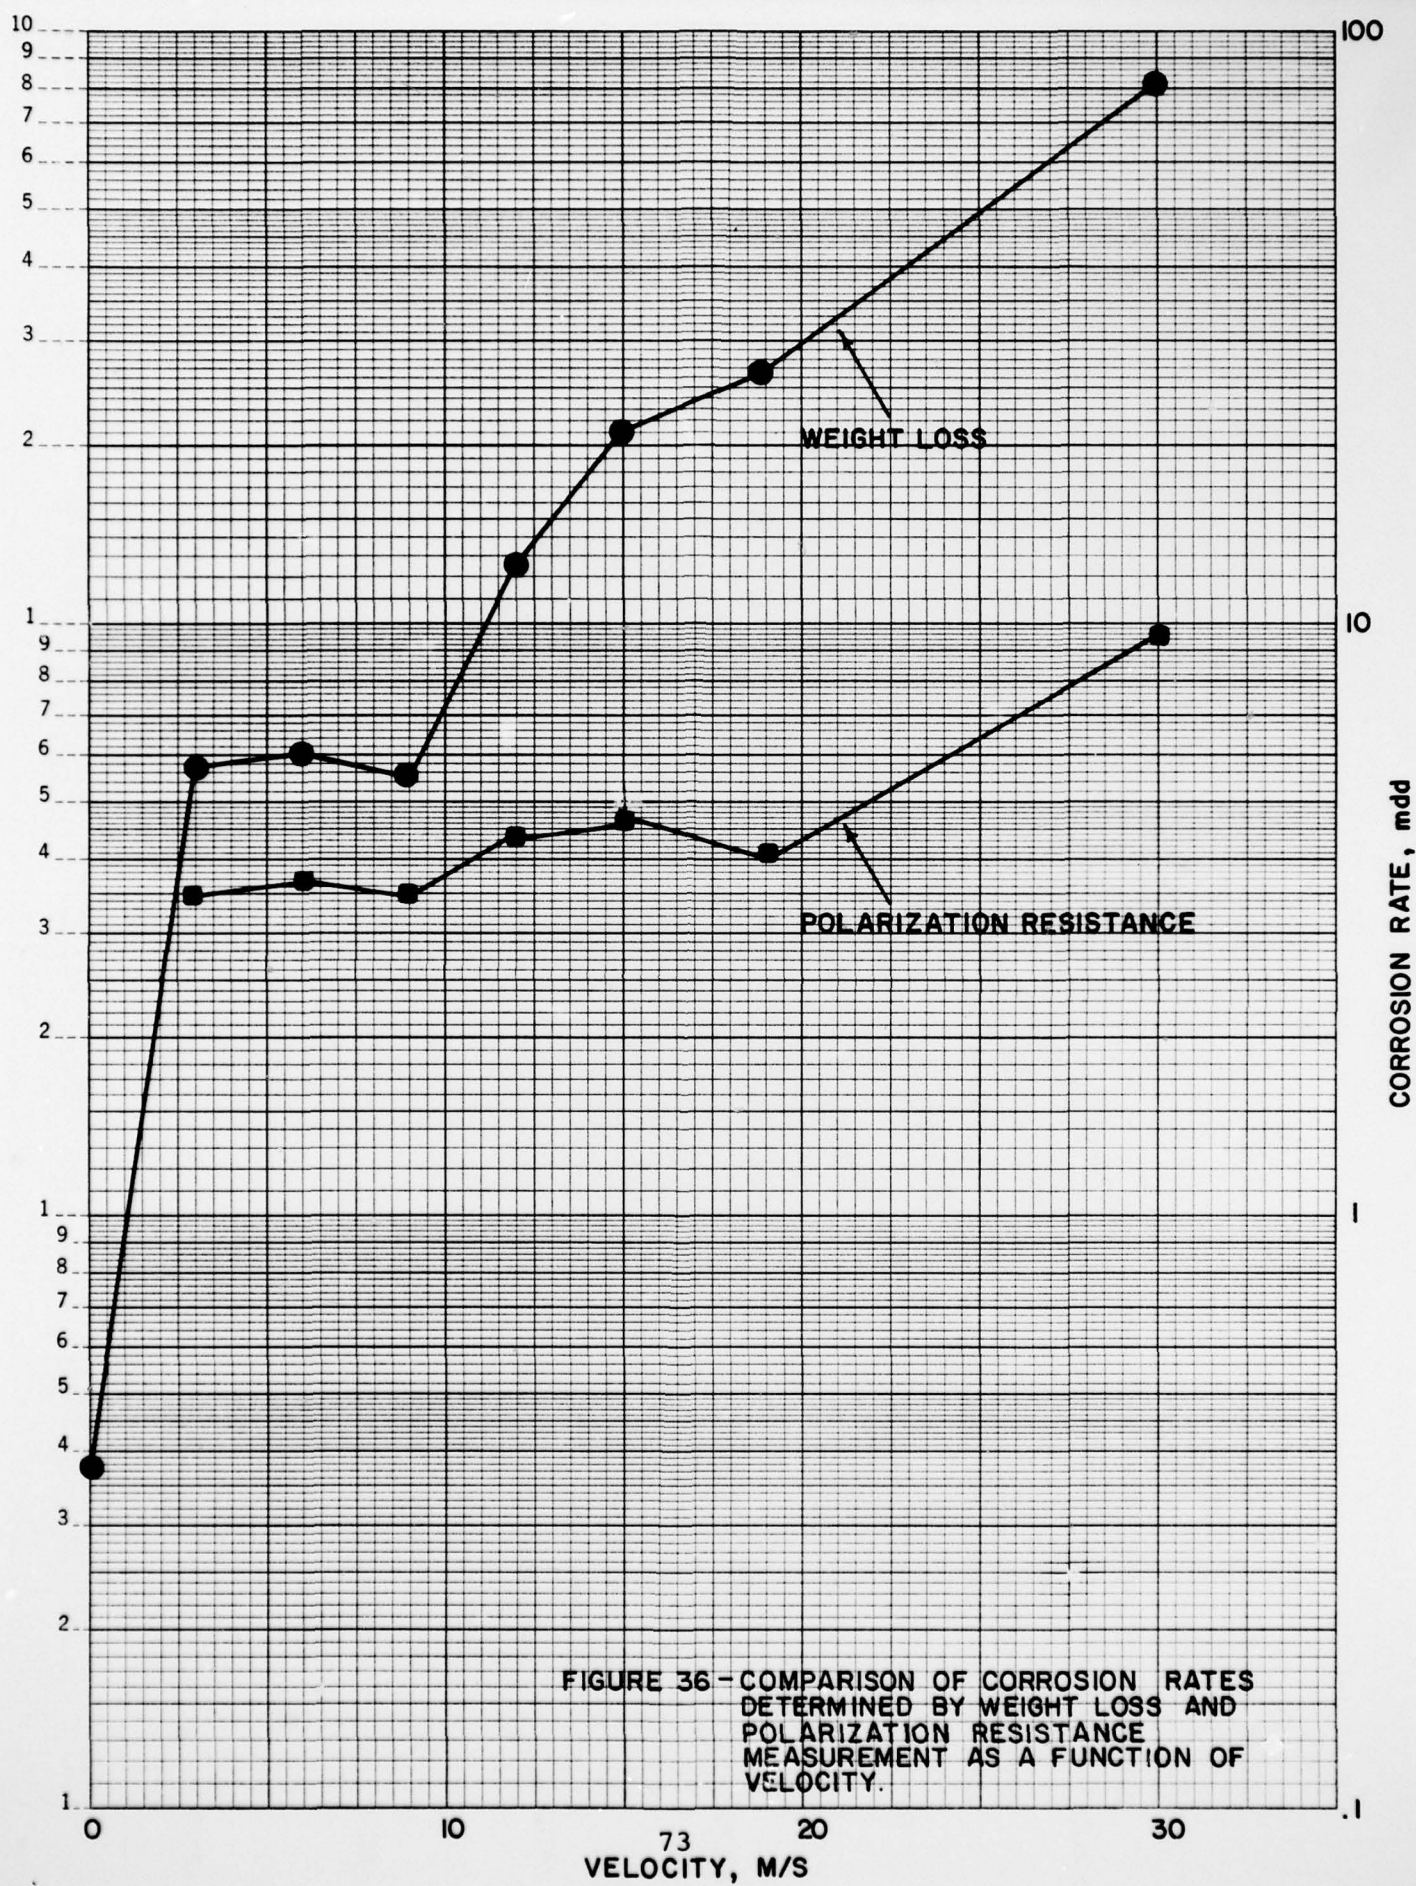
FIGURE 36 - COMPARISON OF CORROSION RATES DETERMINED BY WEIGHT LOSS AND POLARIZATION RESISTANCE MEASUREMENT AS A FUNCTION OF VELOCITY.

Figure 36 presents the average corrosion rate calculated at each velocity over the 35 day test period. Corrosion rates determined by weight loss as previously shown in Figure 1 are shown again for reference. At lower velocities (3 m/s to 9 m/s) the data are within the expected accuracy limits generally associated with the polarization resistance method. However, at higher velocities, there is a considerable difference. The same order-of-magnitude difference was observed in previous work by Davis and Gehring<sup>15</sup>.

Consideration of the criteria necessary for valid application of the polarization resistance technique does not provide a clear-cut answer why such a large difference should exist. The polarization response to a current step observed on an oscilloscope indicated that ohmic voltage drops were not present and thus could not account for the error. It is possible
